NASA TN D-1158

STRUCTURAL DYNAMIC EXPERIENCES OF THE X-15 AIRPLANE

TECHNICAL NOTE D-1158

STRUCTURAL DYNAMIC EXPERIENCES OF THE X-15 AIRPLANE*

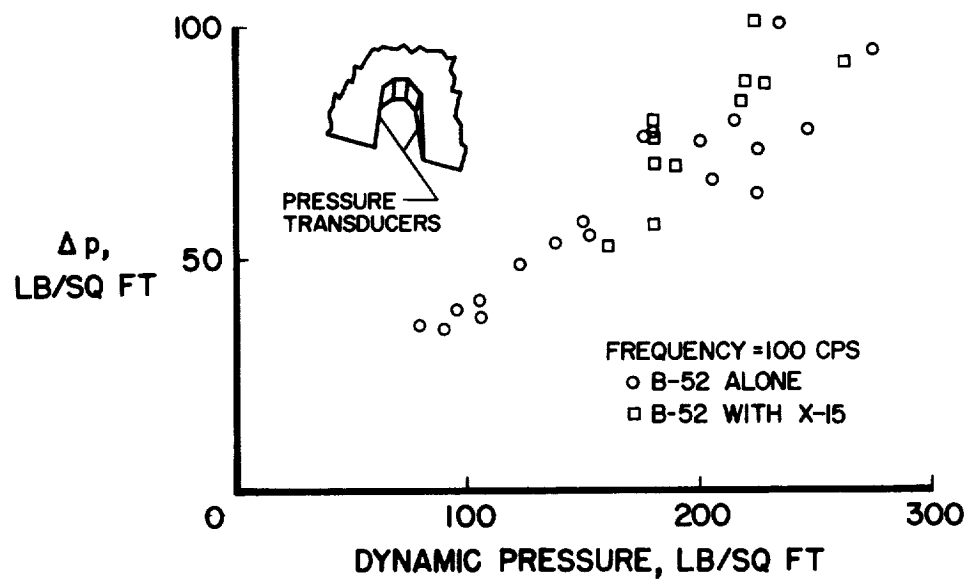
Figure 3 shows the upper vertical tail located in the cutout of the trailing edge of the B-52 wing. On the left is the upper vertical tail in the wing cutout, as viewed over the upper surface of the B-52 wing. On the right is a rear view of the upper vertical tail in the wing cutout. The X-15 pylon and the blunt surface ahead of the X-15 upper vertical tail should be noted. Pressure measurements were made on the sides of the B-52 wing cutout to measure the environment of the vertical tail. These results are shown in figure 4. The magnitude of the pressure fluctuations Δp plotted against dynamic pressure increases with dynamic pressure and has a value of about 40 percent of dynamic pressure and a frequency of about 100 cps. These pressures converted to equivalent noise levels have a value of about 160 decibels at a dynamic pressure of 300 lb/sq ft and 154 decibels at a dynamic pressure of 150 lb/sq ft. Estimates of the fatigue life of the modified construction indicated an acceptable fatigue life in this environment. The modified tail is still subjected to the high-turbulence environment during captive flight and no further difficulty has been experienced to date.

FLUCTUATING PRESSURES IN B-52 WING CUTOUT

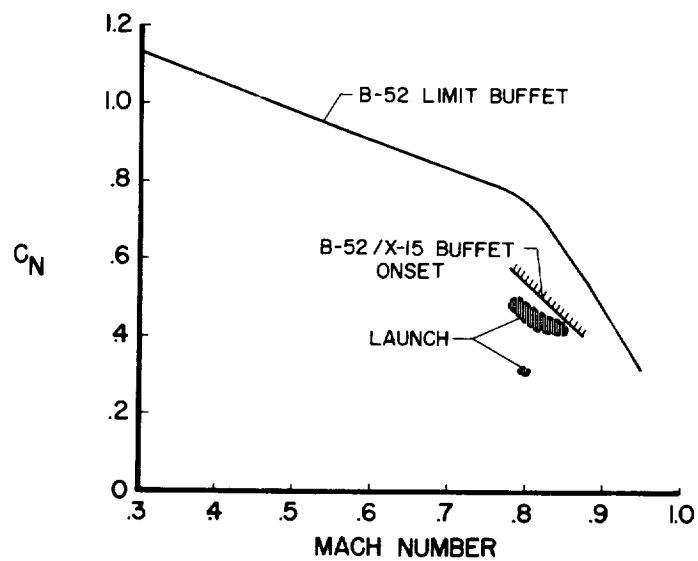
Figure 4

Another area in which the B-52/X-15 combination was of concern was the effect of the X-15 airplane on the buffet characteristics of the B-52 airplane. Wind-tunnel tests indicated that the buffet characteristics of the B-52 airplane would be essentially unaffected by the addition of the X-15 airplane and would not be a problem. Flight experience has shown this to be true. The B-52 limit buffet boundary in terms of normal-force coefficient C_N plotted against Mach number is shown in figure 5. It was originally planned to launch the X-15 airplane at $M \approx 0.78$ at an altitude of 38,000 feet, and initial launches were made within the lower shaded area of the figure. In order to increase the performance of the X-15 airplane and for safety considerations, the launch conditions have been raised to Mach numbers greater than 0.8 at an altitude of 45,000 feet. Subsequent launches have been made, therefore, within the upper shaded area shown in figure 5. The launch conditions currently used are just below the flight-determined buffet boundary for the B-52/X-15 combination, and no problems due to buffeting have been encountered even though the buffet boundary has been penetrated slightly with the X-15 airplane aboard.

B-52/X-15 BUFFET BOUNDARY AND LAUNCH CONDITIONS

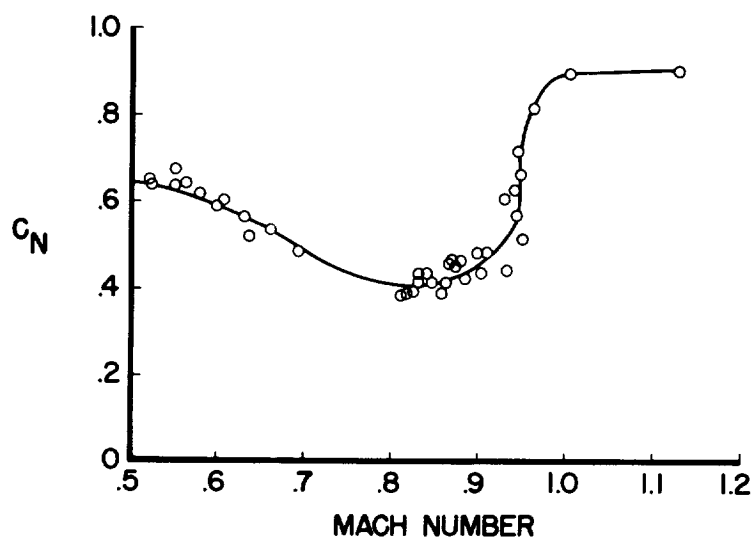
Figure 5

The remainder of the paper is devoted to some of the problems and experiences with the X-15 airplane alone. The buffet boundary established for the X-15 airplane is shown in figure 6 in terms of normal-force coefficient C_N plotted against Mach number. The data were taken

X-15 BUFFET BOUNDARY

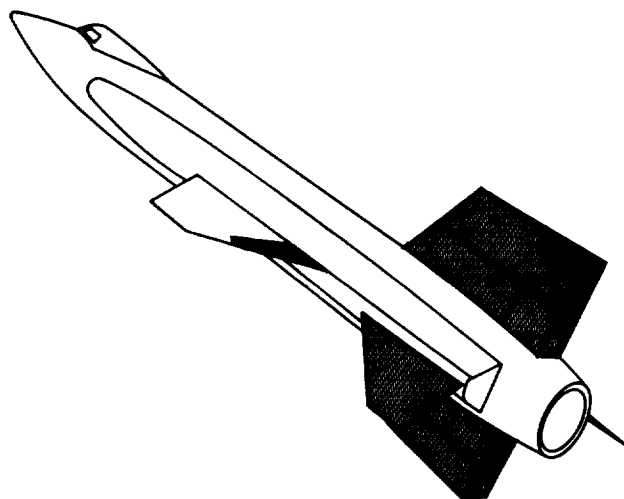
Figure 6

The components in which flutter considerations influenced the design of the X-15 are shown as shaded areas in figure 7 and include the horizontal and vertical tails and landing flaps. Adequate wind-tunnel tests were made on the various components to provide proof tests to 30 percent above the design dynamic pressure of 2,500 lb/sq ft. No indication of flutter has been experienced in X-15 flights.

COMPONENTS DESIGNED BY FLUTTER CONSIDERATIONS
